## **ISONIC EXPERT A-Ring - Multiple Skip True-to-Geometry Shear Wave S-Scan coverage:** • detection and sizing of corrosion damages on both surfaces of annular ring plate in the critical zone and fillet

weld area

- distinguishing position of the damage either at the product side or soil side or in the weld
- recording and 3D Mapping
- measuring of material thickness loss MTL / remaining material thickness RMT

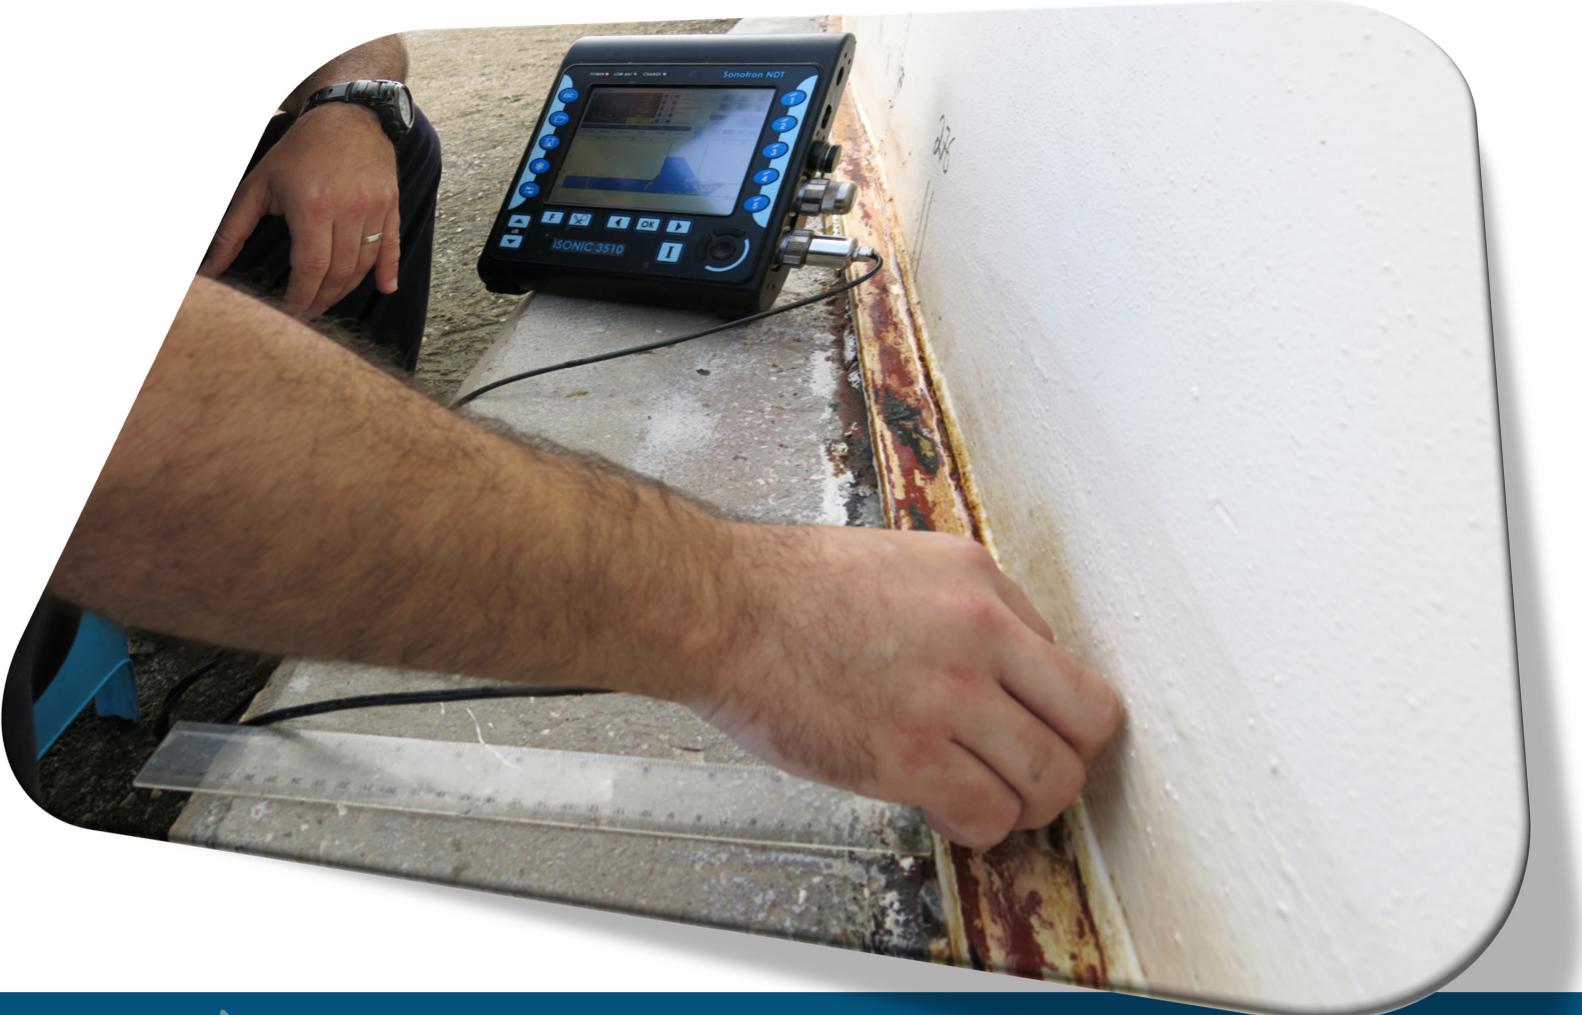
## FMC/TFM Imaging and evaluation of the damage area
